ENVIRONMENTALLY FRIENDLY BEARING SOLUTIONS

WORRY-FREE TRAVEL FOR SEABOURN ELITE

Seabourn Odyssey installed with COMPAC seawater lubricated propeller shaft bearings

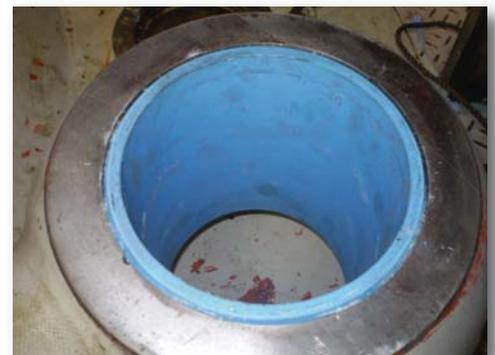
White Rock refits with grease free ThorPlas bearings

They decided to use ThorPlas, a thermoplastic grease-free bushing from Thordon, to replace the small sleeve bushings installed within the link levers for the gate operating mechanism, eliminating yet another 40 grease points. In addition, the servo connecting rod bushings and the PRV connecting rod bushings were replaced with ThorPlas greaseless bushings.

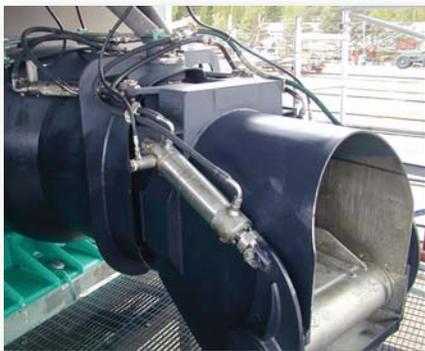
Water jet nozzle equipped with water lubricated Thordon GM2401 line bearings

Water jets are generally used in most Finnish Navy light and fast patrol vessels bigger than open outboard motor boats. The first of their fast attack missile boats to use them were the *Rauma* class vessels. In the propulsion shaft line is a water lubricated line bearing, located inside the stator of the water jet's jet pipe.

After 2000 hrs. running time, a visual inspection was made; both bearings appeared to be in good condition on the surface, with slightly more wear and minor dents on the rubber bearing. The shaft, however, had “clearly more wear on the rubber bearing side,” wrote Majanen. “Clearances (dry) were 0.6mm (0.0236”) with the Thordon GM2401 bearing, and 1.2mm (0.047”) with the rubber bearing.”

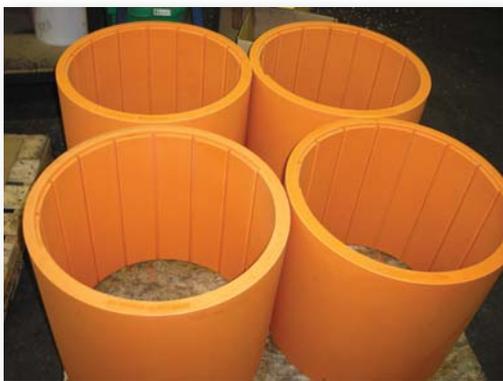
Thordon COMPAC seawater lubricated propeller shaft bearings

In order to control the bearing environment, the COMPAC propeller shaft bearing system includes non-metallic COMPAC bearings, a Thordon Water Quality Package, shaft liners, Thor-Coat shaft coating and a forward seal.

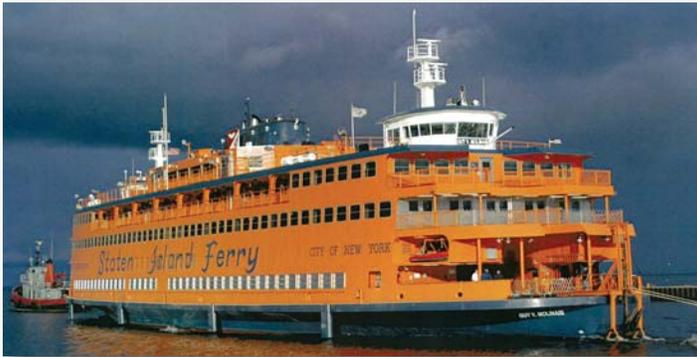
Staten Island Ferry equipped with COMPAC bearings since 2004

Twenty million passengers a year take a ferryboat between Staten Island and Manhattan in New York. At no charge, they get a majestic view of New York Harbor on the 25-minute ride. Those five miles of water started to become a whole lot cleaner in 2004 when Thordon COMPAC propeller shaft bearings and SXL rudder bearings were installed on three Staten Island ferries.

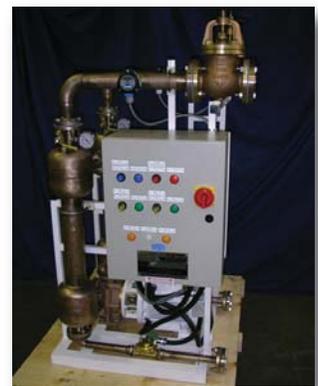
Improved Water Quality Package

Besides helping out with shipyard issues during the construction period, Thordon is equally attentive to items that could impact bearing performance after delivery. When shipyard engineers noticed premature wear on the separators of Thordon’s Water Quality Package, After-sales Service representative Jayson Stansfield replaced the separators with an upgraded unit and set up the water quality packages at an optimum flow level for the cooling water to reduce the amount of wear.
